Fast Beam on the M1

VolkerLaser was contracted by National Highways to carry out concrete repairs to a series of parapets between junctions 21a and 23a of the M1 motorway.

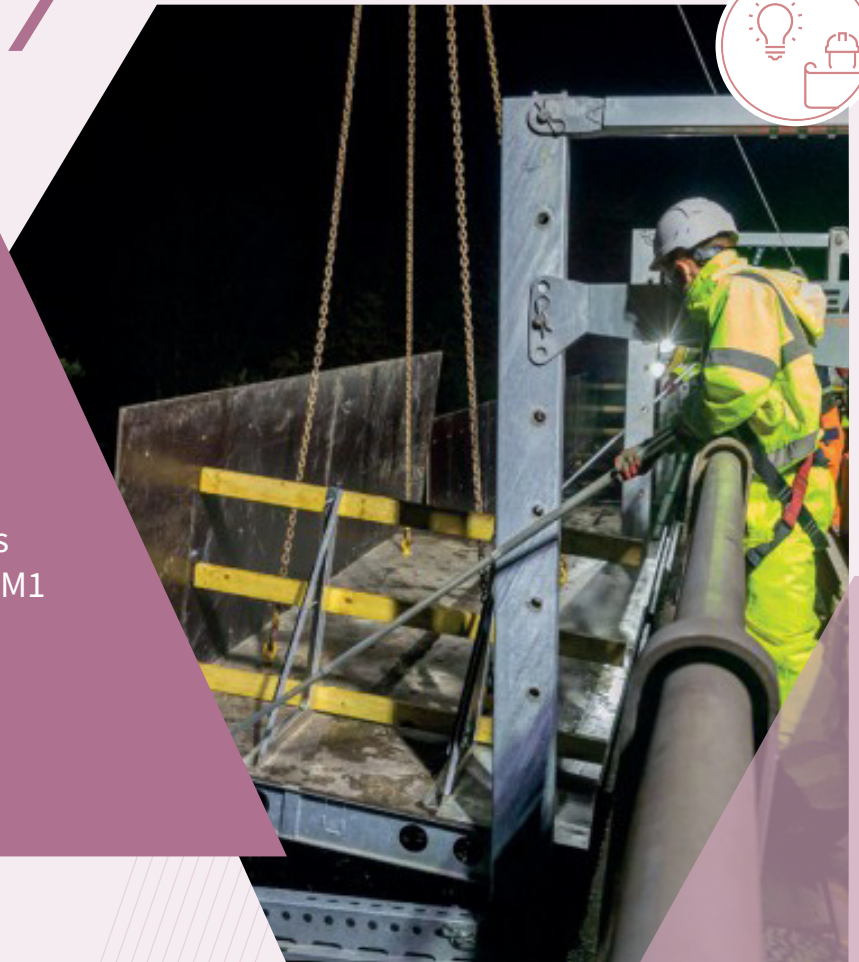
The team was required to complete repair works on three structures over an eight week period, all of which were suffering from alkali silicate reaction. Commonly known as concrete cancer, this is a reaction which occurs over time between the highly alkaline cement paste and the reactive non-crystalline silica, found in most aggregates. This reaction causes expansion of the aggregate and results in spalling and a subsequent loss of strength to the parapet walls.

The project had logistical challenges as, due to watercourses and heavy growth below the bridges, access was extremely restricted and a previously installed cathodic protection system was in place, which needed to be preserved. In order to overcome these issues and without compromising the integrity of the bridge, the team developed a workable solution with the brand new and innovative access system - Fast Beam.

The adjustable hydraulic platform was mounted onto kentledge blocks, designed as part of the temporary works, allowing the team to access the parapet walls from the motorway's hard shoulder with minimal disruption to traffic.

The scope of works saw the team temporarily remove the existing parapet railings and break out areas of affected parapet wall, on each of the three structures. The team then treated and replaced existing reinforcement, installed new parapet post bolt cradles, and cast new sections of parapet wall where needed. The railings were then reinstated before Fast Beam was uninstalled, marking project completion on time and to budget.
